**Flood Control Project Maintenance  
Levee Inspections**  
**LMA District Cover Sheet**  
**Spring 2020 Levee Inspection Results**

**Reclamation District No. 0017 Mossdale**

**Levee Inspection Report By Mile - Spring 2020**

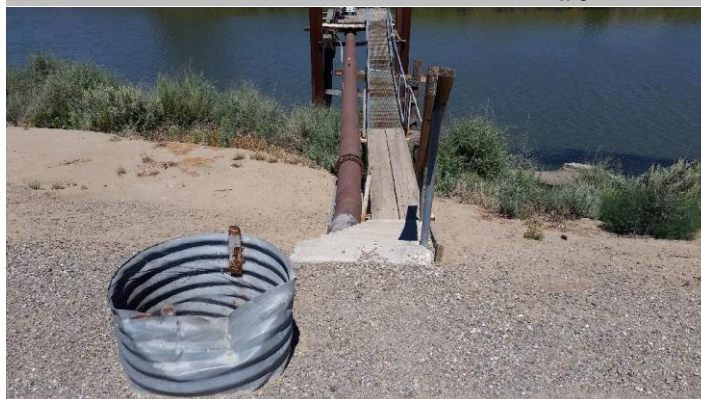
Photo 1 of 3 : UCIP\_SP\_2020\_56149\_75723.jpg

UCIP Comments: 2/10/2020 DSID 33 was issued a permit on October 18, 2019 (Permit # 15116-1) as a result of ENF# 15428. Work has not commenced but we believe it will after the flood season (D. Sanoski - DWR UCIP, per D. Ismailyan - CVFPB).9/5/2018 WS slope severe erosion appears to have been fixed somewhat, however, some erosion still present. Massive LS slippage and sink hole present. Notified LMA Engineer, DWR Inspector, and CVFPB Enforcement. Recommend monitoring of site through flood season, and remains Urgent until full inspection of site (D. Sanoski - DWR UCIP).12/01/2017 Inspection update is based on supporting documentation provided by KSN Inc, R. Toy, on November 18, 2016. Levee slope repair was performed on the LS slope area. Crossing remains Urgent--internal erosion visible from WS where pipe daylights has not been addressed. Recommend internal inspection of pipe through the levee to determine pipe condition. (DWR UCIP - o. magana) 7/12/2016 Same as last inspection--internal erosion on WS and LS slope slipping with visible head scarp. Internal erosion visible from WS where pipe daylights. LS slope slipping with visible head scarp approximately 6-inches. Need to coordinate with owner to address issue. Owner will need to work with DWR Inspector and CVFPB to comply with Title 23 requirements. Recommend internal integrity inspection of crossing to determine pipe condition through levee. (DWR UCIP - omagana)5/19/2015 Signs of internal erosion visible on waterward side where pipe daylights. Slope slumping visible on landward side where previous levee damage was present. Need to contact owner and KSN, LMA engineering firm, to coordinate potential issues with pipe. (DWR UCIP - omagana)2/04/2010 Pipe failure--internal erosion visible on waterward and landward side. Recommend LMA superintendent notify owner to stop using crossing to avoid further damage to levee slope. Owner will need to coordinate with DWR Inspector and CVFPB to address pipe failure per Title 23 requirements. (DWR UCIP - omagana)

View of WS.

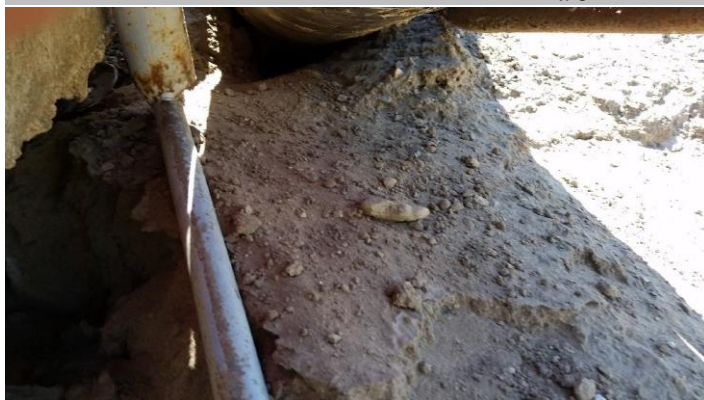
Photo 2 of 3 : UCIP\_SP\_2020\_56149\_75724.jpg

Internal erosion still visible on WS.

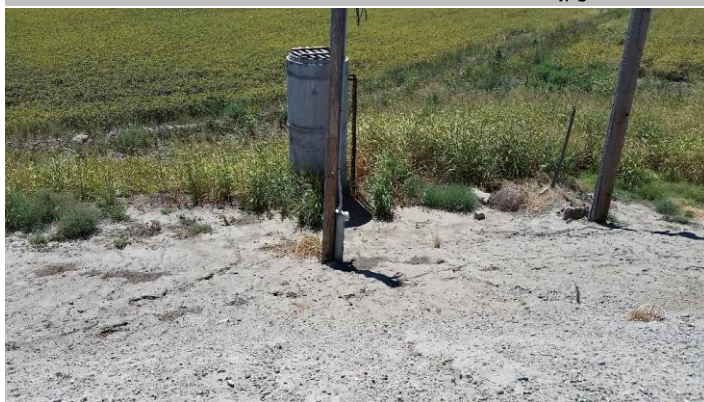
Photo 3 of 3 : UCIP\_SP\_2020\_56149\_75720.jpg

View of LS.

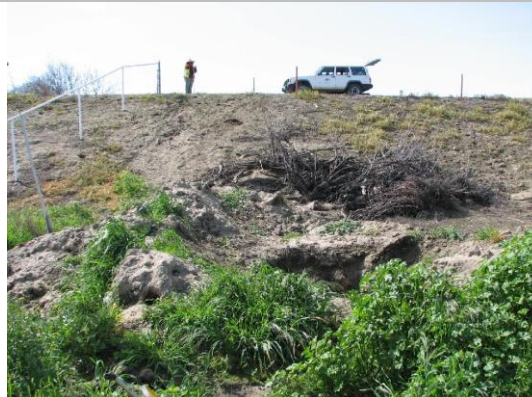
Photo 1 of 3 : UCIP\_SP\_2020\_52587\_72215.jpg

DS\_ID:34  
 FS\_ID:52587  
 EP\_NO: 15117  
 Repair Type: Non-Urgent  
 Crossing Status: Found  
 UCIP Comments: 12/01/2017 Supporting documentation (field report) was received from KSN, Inc. R. Toy, addressing the repair of the leaking pipe and levee slope at this location. Compaction tests associated with the repair have not been received -- need to coordinate with CVFPB, LMA, and DWR Inspector. (DWR UCIP - O. Magana)07/12/2016 Crossing has been downgraded from Urgent to Non-Urgent--LS levee slope repaired. Levee slope was disturbed to repair leaky pipe--LS splice approximately 20-30 feet off the LS toe. Need to contact owner to determine if any documentation is available to support repair extent or internal integrity inspection of pipe through levee. (DWR UCIP - omagana)02/04/2010 Section of landward slope exposed--Need to contact owner to address cut on levee and determine status of crossing. Dense vegetation limits the inspector's visibility to identify signs of pipe failure (leaks) along the slope. Recommend removing vegetation along pipe alignment to conduct proper inspection of structure. (DWR UCIP - omagana)

View of LS.

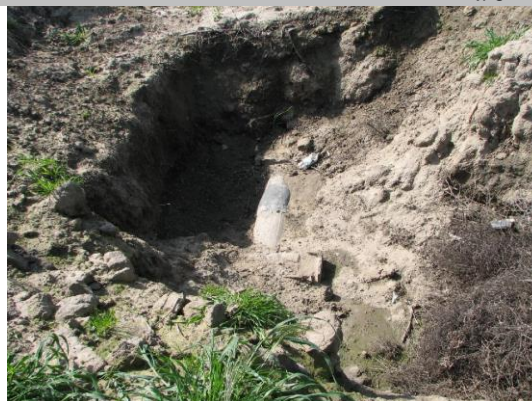
Photo 2 of 3 : UCIP\_SP\_2020\_52587\_72214.jpg

Section of levee slope exposed on LS.

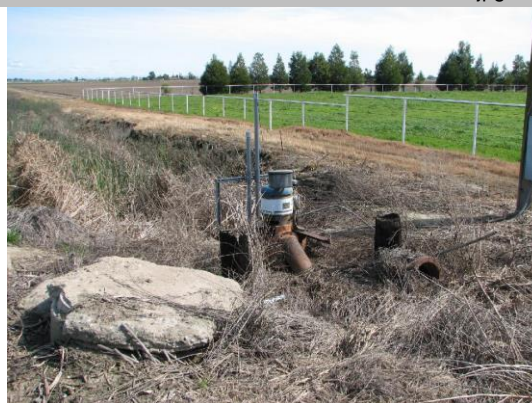
Photo 3 of 3 : UCIP\_SP\_2020\_52587\_72213.jpg

Pump station located on LS toe.

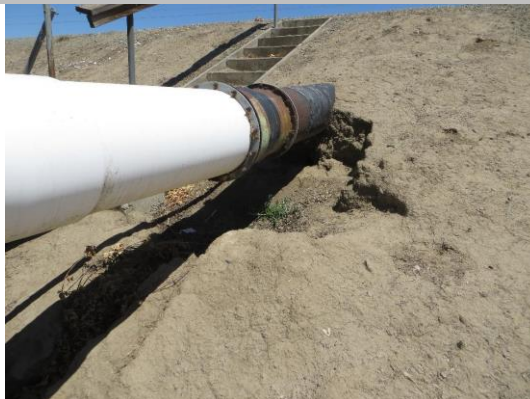
Photo 1 of 3 : UCIP\_SP\_2020\_45998\_74483.jpg

DS\_ID:35  
FS\_ID:45998  
EP\_NO: 15118  
Repair Type: Non-Urgent  
Crossing Status: Found  
UCIP Comments: 05/19/2015 Erosion is still present on waterward side--wet soil along pipe alignment (where pipe section is exposed). Burrow activity is also present at this location. Recommend contacting owner to address burrow activity. 02/04/2010 Erosion visible on waterward side visible at pipe daylight. Need to contact owner to address potential pipe failure. Need to determine status of crossing.  
FIELD\_STRUCT\_DESC: 14-inch steel irrigation pipe through levee, 3.32 feet below levee crown. Siphon breaker on landside (LS) shoulder. Pump on platform in channel, wooden walkway extends from pump platform to waterside (WS) slope, concrete stairway extends from walkway to WS shoulder and a standpipe is located 2 feet from the LS toe. (14-inch pipe installed and existing 12-inch pipe removed under Permit No. 15118, 1989 - L. Matlock) [Additional Reference(s): DWR Levee Logs, 1981 and 2003]

(2015) View of waterward side--erosion at pipe daylight.

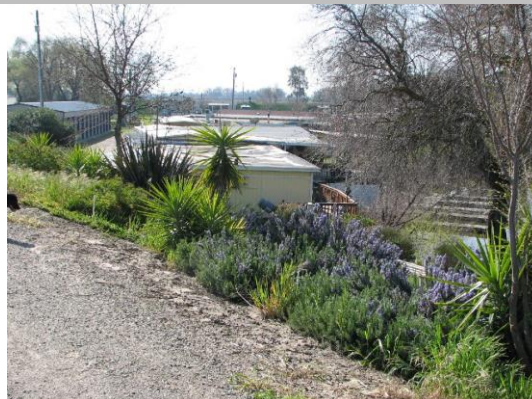
Photo 2 of 3 : UCIP\_SP\_2020\_40669\_72238.jpg

View of waterward side.

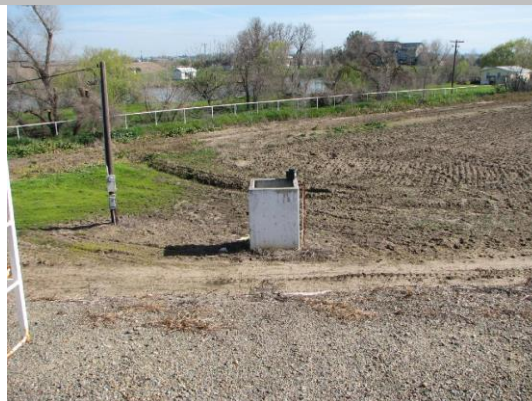
Photo 3 of 3 : UCIP\_SP\_2020\_40669\_72237.jpg

Distribution box located on landward side.

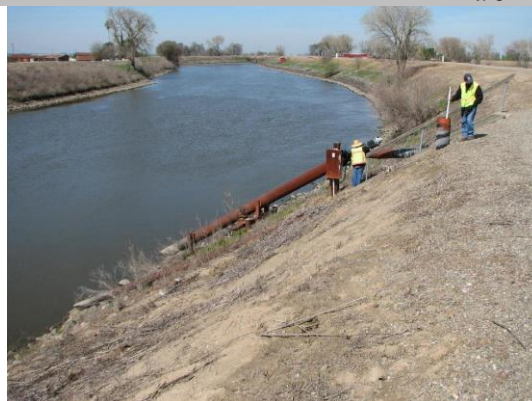
Photo 1 of 3 : UCIP\_SP\_2020\_40672\_72270.jpg

DS\_ID:38  
FS\_ID:40672  
EP\_NO: 15121  
Repair Type: Non-Urgent  
Crossing Status: Found  
UCIP Comments: Pipe section at waterward toe is missing wall. Need to coordinate with owner to determine integrity of pipe section through levee. This crossing is a good candidate for video inspection to determine internal condition of pipe.  
FIELD\_STRUCT\_DESC: 10-inch steel drainage through the levee, 4 feet below crown. (10-inch pipe authorized under Permit No. 15121, 1989 - R. Muller, additional work also includes removal of 12-inch and two 9-inch pipes at different locations and installation of a 12-inch pipe; 10-inch pipe was installed during the levee work approved under Permit No. 15014, 1989-Reclamation District [RD0017]) [Additional Reference(s): DWR Levee Logs, 1981 and 2003]  
FS Date: 2/4/2010

View of pipe section on waterward side.

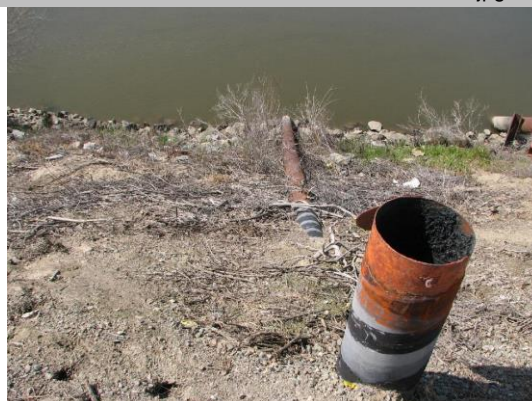
Photo 2 of 3 : UCIP\_SP\_2020\_40672\_72267.jpg

View of waterward side.

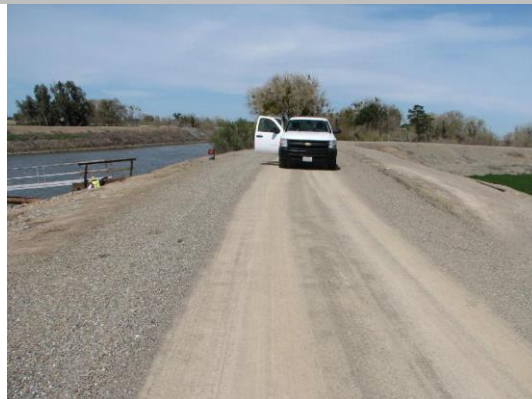
Photo 1 of 3 : UCIP\_SP\_2020\_40677\_72289.jpg

DS\_ID:40  
FS\_ID:40677  
EP\_NO: 15123  
Repair Type: Non-Urgent  
Crossing Status: Found  
UCIP Comments: Landowner mentioned power line was stolen crossing was non-functional during inspection. Potential erosion underneath walkway--need to confirm loose soil. Need to contact owner to determine status of crossing. If crossing is no longer used need to coordinate with CVFPB for proper abandonment.  
FIELD\_STRUCT\_DESC: 16-inch steel irrigation pipe through levee, 2.70 feet below the levee crown. Siphon breaker on waterside (WS) shoulder. Ramp on platform in channel, walkway from pump platform to WS slope, standpipe located at landside (LS) berm toe. (16-inch pipe installed and authorized under Permit No. 15123-1989, also includes removal of two existing pipes, 8-inch and 10-inch) [Additional Reference(s): DWR Levee Logs, 1981 and 2003]  
FS Date: 2/4/2010

View of levee crown at crossing.

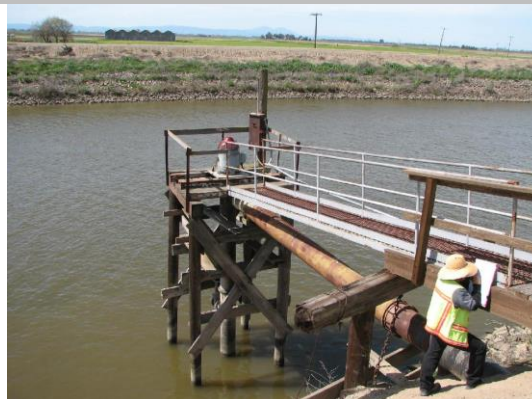
Photo 3 of 3 : UCIP\_SP\_2020\_40677\_72292.jpg

View of waterward side.

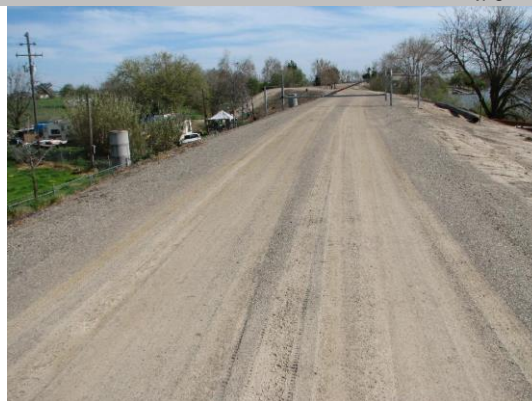
Photo 1 of 3 : UCIP\_SP\_2020\_40679\_72307.jpg

DS\_ID:42  
FS\_ID:40679  
EP\_NO: 15077  
Repair Type: Non-Urgent  
Crossing Status: Found  
UCIP Comments: Surface erosion on waterward slope. Abandoned pipe section left on waterward slope. Need to contact owner to obtain additional information about crossing.  
FIELD\_STRUCT\_DESC: 12-inch steel irrigation pipe through levee. Invert of pipe 3.67 feet below levee crown. Siphon breaker on landside (LS) shoulder. Pump on platform in channel, walkway from pump platform to waterside (WS) shoulder. Standpipe located 15 feet from the LS toe. (12-inch pipe authorized under Permit No. 15077, 1989 - J. P. Leal, existing 12-inch pipe removed) [Additional Reference(s): DWR Levee Logs, 1981 and 2003, 12-inch pipe]  
FS Date: 2/4/2010

Overview of levee crown at crossing.

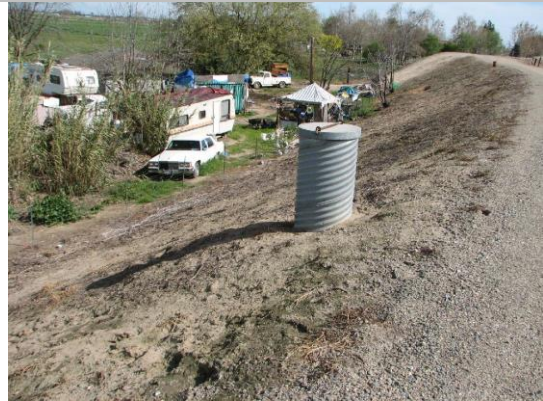
Photo 2 of 3 : UCIP\_SP\_2020\_40679\_72306.jpg

CMP riser located on landward slope.

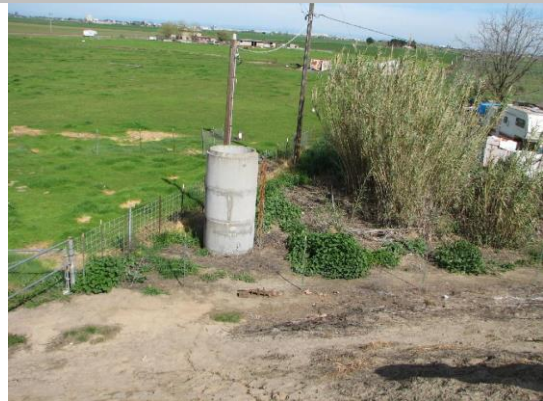
Photo 3 of 3 : UCIP\_SP\_2020\_40679\_72305.jpg

Standpipe visible on landward toe.

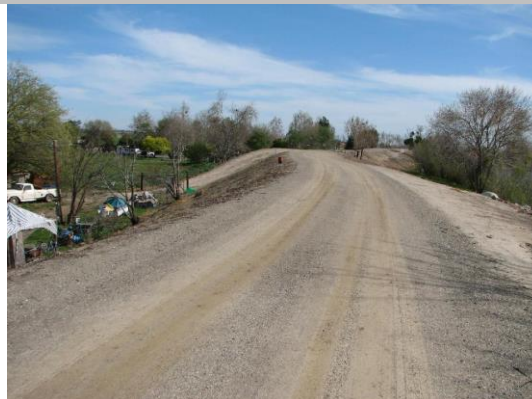
Photo 1 of 3 : UCIP\_SP\_2020\_40680\_72314.jpg

Comment Code						
Inspector Comment						
DS_ID:43 FS_ID:40680 EP_NO: 15078 Repair Type: Non-Urgent Crossing Status: Found UCIP Comments: Crossing is non-functional recommend contacting owner to determine status of crossing. If crossing is no longer used need to coordinate with CVFPB for proper abandonment. FIELD_STRUCT_DESC: 4-inch irrigation pipe of unknown material through levee, 2.89 feet below levee crown. Siphon breaker on landside (LS) shoulder. Pump on waterside (WS) berm. (4-inch pipe authorized under Permit No. 15078, 1989 - S. and F. Aurelio, existing 4-inch pipe removed) [Additional Reference(s): DWR Levee Logs, 1981 and 2003] FS Date: 2/4/2010

Overview of levee crown at crossing.

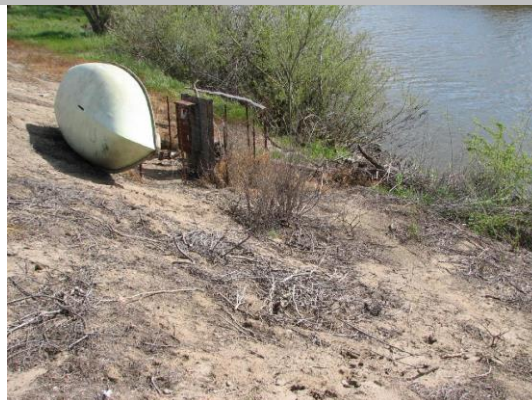
Photo 2 of 3 : UCIP\_SP\_2020\_40680\_72313.jpg

Abandoned boat protecting pump station located on waterward side.

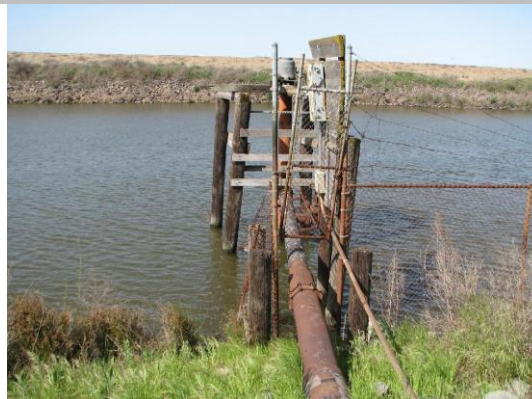
Photo 2 of 3 : UCIP\_SP\_2020\_40681\_72328.jpg

Pipe, pump, and platform located on waterward side.

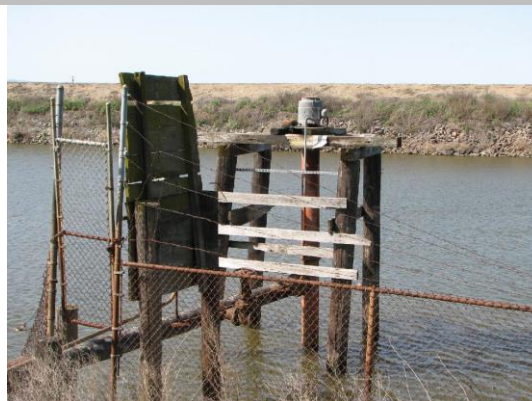
Photo 3 of 3 : UCIP\_SP\_2020\_40681\_72330.jpg

Pump station fenced off on waterward side.

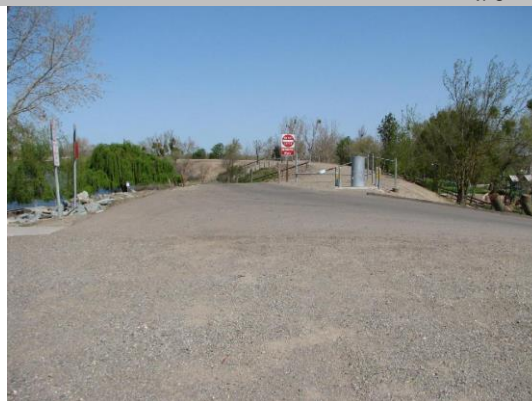
Photo 1 of 3 : UCIP\_SP\_2020\_40682\_72322.jpg

DS\_ID:99  
FS\_ID:40682  
EP\_NO: 17643  
Repair Type: Non-Urgent  
Crossing Status: Found  
UCIP Comments: Need to coordinate with owner to determine when the other 3 crossings will become online.  
FIELD\_STRUCT\_DESC: [Stonebridge Pump Station/Dos Reis Road Outfall Structure] 30-inch and 36-inch combination cement motar lined and coated steel drainage pipe through the levee, 2-feet below the levee crown. Concrete headwall on waterside (WS) toe and a 36-inch tidal flex valve on outlet of pipe. 36-inch pipe section starts at WS headwall and is reduced with a 30-inch pipe on WS. The 30-inch pipe continues through from WS to LS levee. Structure was designed for 5 crossings however only 1 crossing is active (30-inch pipe and 36-inch combination pipe through the levee authorized under Permit No. 17643, 2005 - City of Lathrop, structure can accommodate five 36-inch pipes discharge pipes - only one 36-inch pipe active).

Overview of levee crown at crossing.

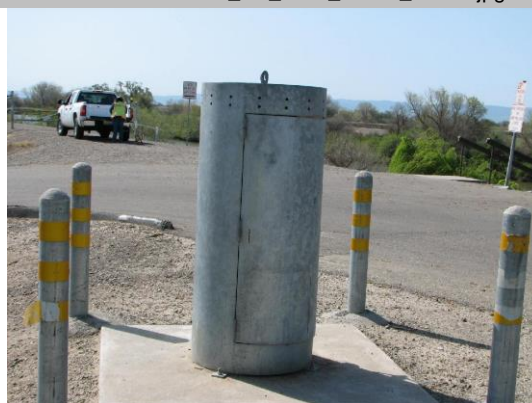
Photo 2 of 3 : UCIP\_SP\_2020\_40682\_72321.jpg

Relief valve located on landward shoulder.

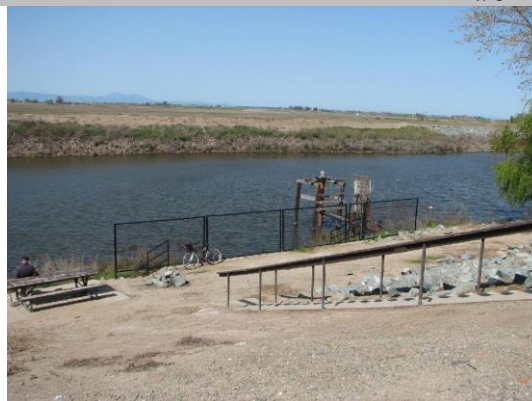
Photo 3 of 3 : UCIP\_SP\_2020\_40682\_72320.jpg

View of waterward side.

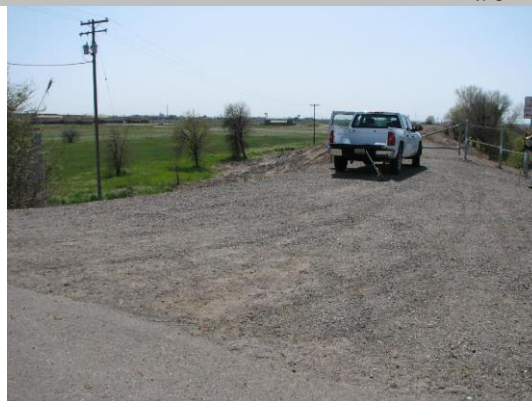
Photo 1 of 3 : UCIP\_SP\_2020\_40683\_72333.jpg

DS\_ID:284  
 FS\_ID:40683  
 EP\_NO: 15079  
 Repair Type: Non-Urgent  
 Crossing Status: Found  
 UCIP Comments: Potential leak at standpipe--unable to confirm if crossing is operable. If crossing is no longer in use owner will need to coordinate with DWR inspector and CVFPB to remove according to Title 23 requirements. Unable to determine if crossing is in use.  
 FIELD\_STRUCT\_DESC: 2 of 2. 10 inch pipe also referenced as 478+22, old 6 inch pipe was removed per encroachment recordation.  
 FS Date: 2/4/2010

Overview of levee crown at crossing.

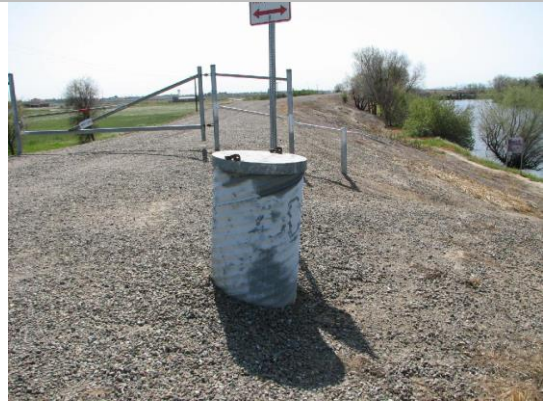
Photo 2 of 3 : UCIP\_SP\_2020\_40683\_72332.jpg

CMP riser located on waterward shoulder.

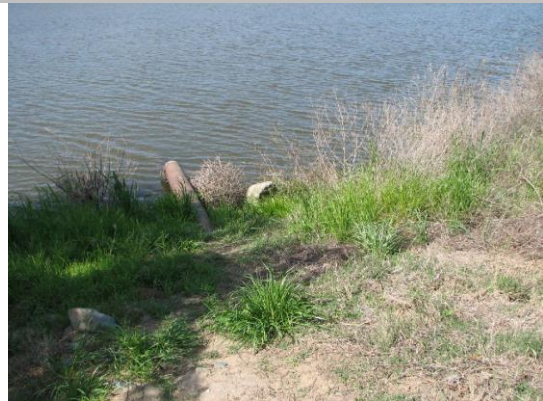
Photo 3 of 3 : UCIP\_SP\_2020\_40683\_72335.jpg

Pipe visible on waterward side.

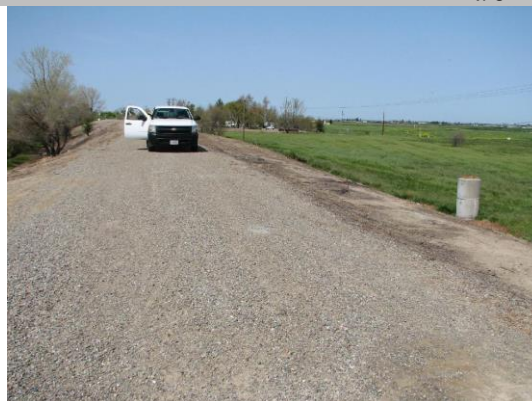
Photo 1 of 3 : UCIP\_SP\_2020\_40684\_72340.jpg

Comment Code						
Inspector Comment						
DS_ID:97						
FS_ID:40684						
EP_NO: 15080						
Repair Type: Non-Urgent						
Crossing Status: Found						
UCIP Comments: Pipe appears no longer in use. If crossing is no longer in use owner will need to coordinate with DWR inspector and CVFPB to remove according to Title 23 requirements. Unable to determine if crossing is in use.						
FIELD_STRUCT_DESC: 6-inch steel irrigation pipe through the levee, 4.43-feet below crown. Pump on waterside (WS) slope, siphon breaker on WS shoulder, and standpipe on landside (LS) toe. (7-inch pipe installed and was authorized under Permit No. 15080, 1989 - J. P. Aven, existing 6-inch pipe removed).						
FS Date: 2/4/2010

Overview of levee crown at crossing.

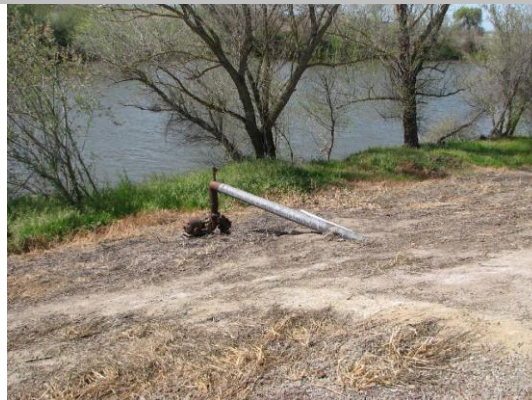
Photo 2 of 3 : UCIP\_SP\_2020\_40684\_72342.jpg

View of waterward side.

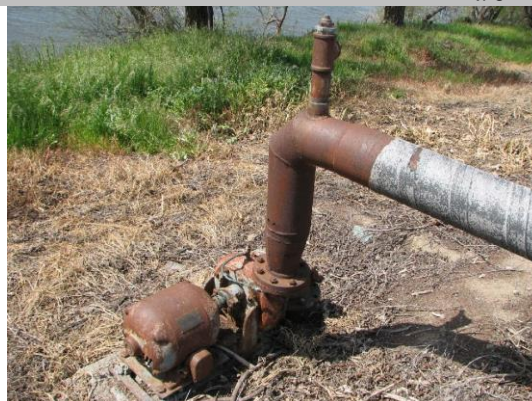
Photo 3 of 3 : UCIP\_SP\_2020\_40684\_72338.jpg

Pump and pipe located on waterward slope.

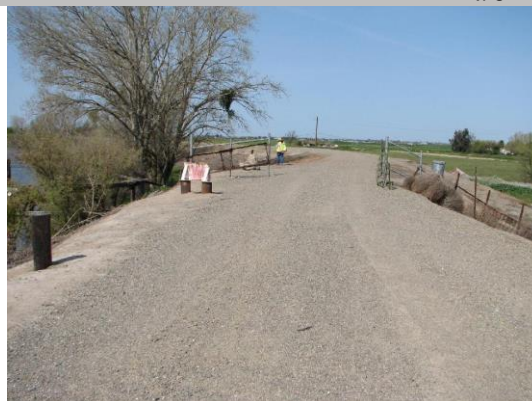
Photo 1 of 3 : UCIP\_SP\_2020\_40685\_72351.jpg

Comment Code						
Inspector Comment						
DS_ID:98 FS_ID:40685 EP_NO: 15081 Repair Type: Non-Urgent Crossing Status: Found UCIP Comments: Erosion present on waterward toe underneath piles. Need to coordinate with owner to address issue on waterward side and to determine status of crossing. FIELD_STRUCT_DESC: 16-inch asphalt coated and wrapped steel irrigation pipe through the levee, 2.6-feet below the crown. Siphon breaker located on landside (LS). Stand pipe located at LS toe. Pump on Platform at waterside (WS) toe. (16-inch pipe installed under Permit No. 15081, 1989 - I. N. Robinson, Jr., existing 14-inch pipe removed) FS Date: 2/4/2010

Overview of levee crown at pipe crossing.

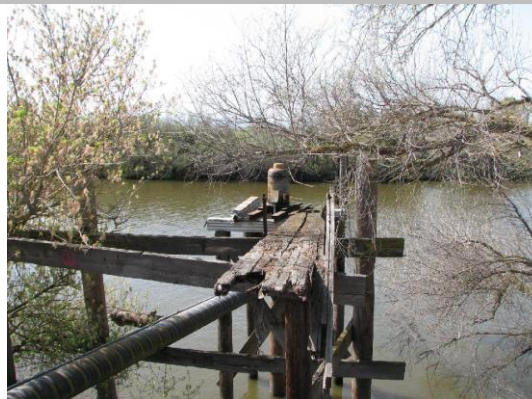
Photo 3 of 3 : UCIP\_SP\_2020\_40685\_72348.jpg

Pump station located on platform located on waterward side.

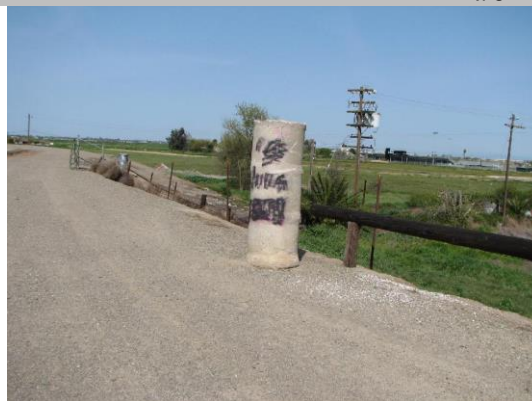
Photo 1 of 2 : UCIP\_SP\_2020\_40686\_72353.jpg

DS\_ID:804  
 FS\_ID:40686  
 EP\_NO: N/A  
 Repair Type: Non-Urgent  
 Crossing Status: Indicator Found  
 UCIP Comments: Unable to find any appurtenances need to coordinate with owner to obtain additional information about crossing. Standpipe appears abandoned. If crossing is no longer in use owner will need to coordinate with DWR inspector and CVFPB to remove according to Title 23 requirements. Unable to determine if crossing is in use.  
 FIELD\_STRUCT\_DESC: Standpipe located on levee crown.  
 FS Date: 2/4/2010

Standpipe located on levee crown.

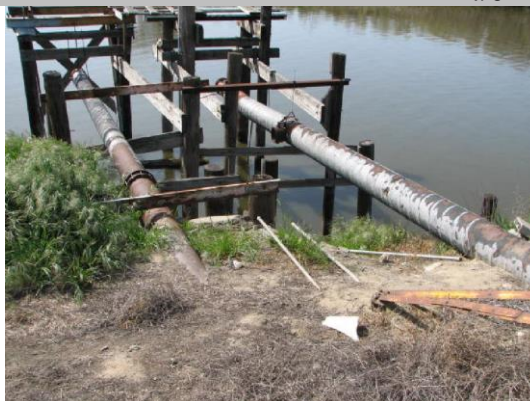
Photo 2 of 3 : UCIP\_SP\_2020\_40687\_72356.jpg

View of waterward side--no pumps present anymore.

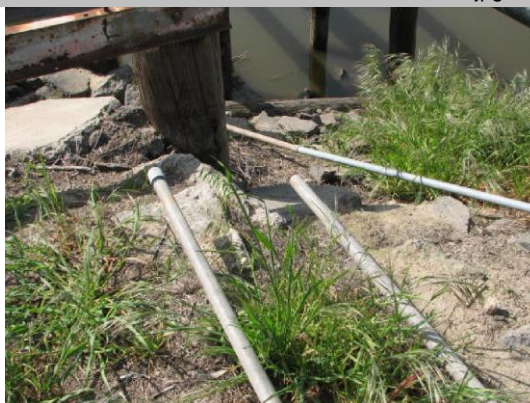
Photo 3 of 3 : UCIP\_SP\_2020\_40687\_72358.jpg

Conduit lines present on waterward side--no connection.

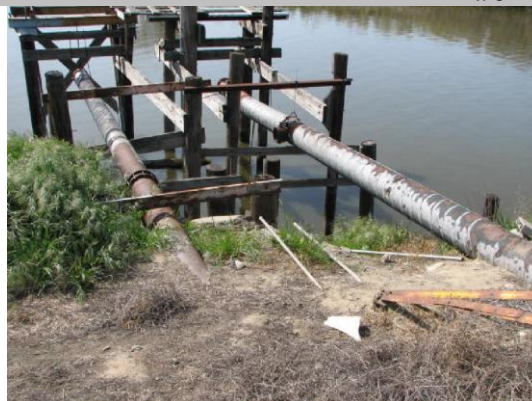
Photo 1 of 3 : UCIP\_SP\_2020\_40688\_72361.jpg

DS\_ID:288  
FS\_ID:40688  
EP\_NO: 15082  
Repair Type: Non-Urgent  
Crossing Status: Found  
UCIP Comments: Pump was removed and no power connection visible. Crossing appears abandoned. If crossing is no longer in use owner will need to coordinate with DWR inspector and CVFPB to remove according to Title 23 requirements. Unable to determine if crossing is in use.  
FIELD\_STRUCT\_DESC: 16- inch asphalt coated and wrapped steel irrigation pipe through levee, 2.6-feet below the crown. Pump missing from platform on waterside (WS). Siphon breaker inside 24-inch corrugated metal pipe (CMP) riser on landside (LS) shoulder. 1.5-inch galvanized iron electrical conduit at same location. (16-inch pipe installed under Permit No. 15082, 1989 - I. N. Robinson, Jr., also authorized under permit two existing 14-inch pipes removed and installation of 20-inch pipe in general area)  
FS Date: 2/4/2010

View of pipe on waterward side.

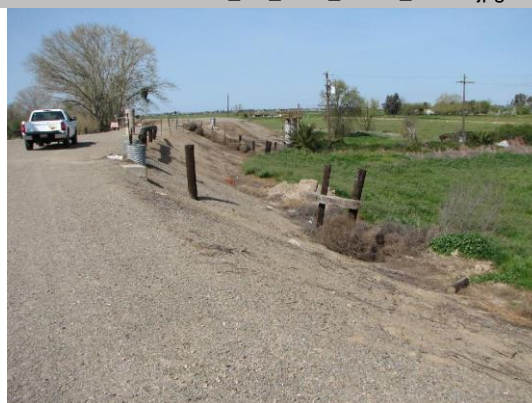
Photo 2 of 3 : UCIP\_SP\_2020\_40688\_72360.jpg

View of landward side.

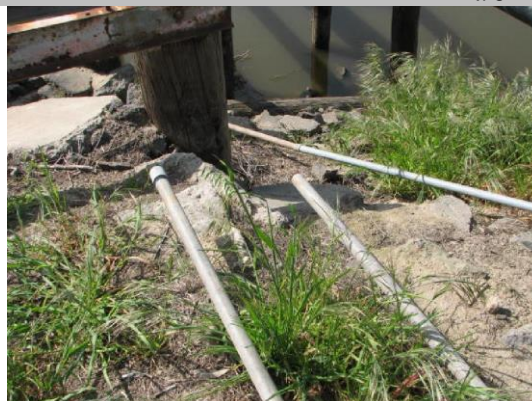
Photo 3 of 3 : UCIP\_SP\_2020\_40688\_72359.jpg

Conduits visible on waterward side--no connection.

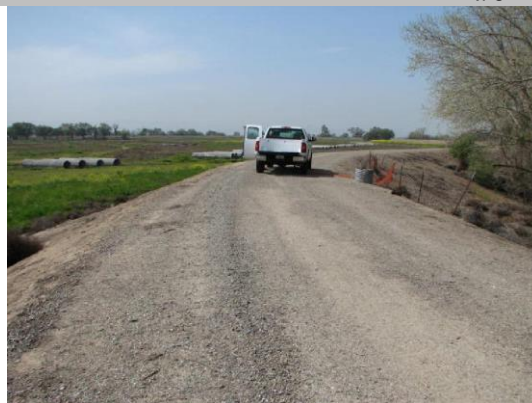
Photo 1 of 3 : UCIP\_SP\_2020\_40689\_72367.jpg

DS\_ID:805  
 FS\_ID:40689  
 EP\_NO: N/A  
 Repair Type: Non-Urgent  
 Crossing Status: Indicator Found  
 UCIP Comments: Only siphon breakers were found on landward shoulder no other appurtenances were found. If crossing is no longer in use owner will need to coordinate with DWR inspector and CVFPB to remove according to Title 23 requirements. Unable to determine if crossing is in use.  
 FIELD\_STRUCT\_DESC: Siphon breaker located on landward shoulder.  
 FS Date: 2/4/2010

View of levee crown at crossing.

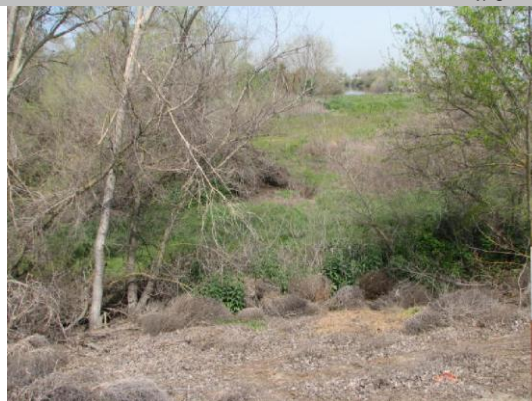
Photo 2 of 3 : UCIP\_SP\_2020\_40689\_72366.jpg

View of landward side.

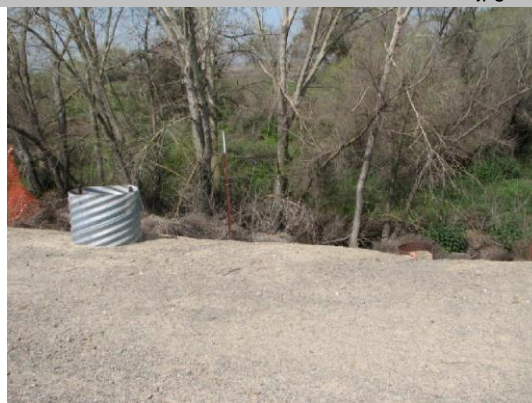
Photo 3 of 3 : UCIP\_SP\_2020\_40689\_72369.jpg

LM Start	<b>7.89</b>	Rating **	M	Issue No.	<b>135 (cont)</b>
LM End	<b>7.89</b>	Issue Type +	En	Location *

CMP riser located on landward side.

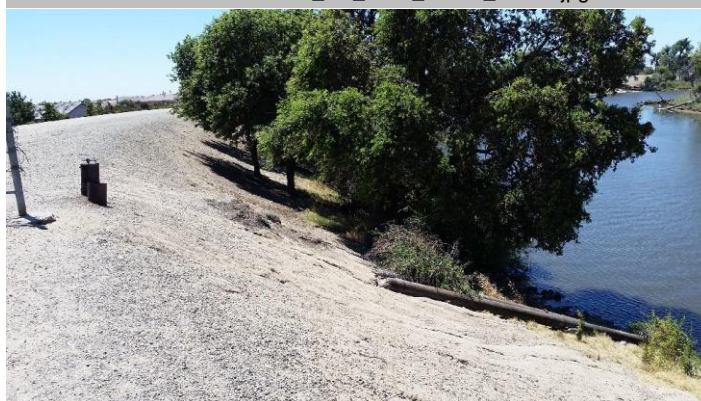
Photo 1 of 3 : UCIP\_SP\_2020\_53331\_75741.jpg

DS\_ID:285  
FS\_ID:53331  
EP\_NO: 15083  
Repair Type: Urgent  
Crossing Status: Found  
UCIP Comments: 9/5/2018 Same as last inspection; WS pipe section completely corroded at section end. Crossing remains Urgent (D. Sanoski - DWR UCIP). 7/12/2016 Same as last inspection--WS pipe section deteriorated. Per Rick Toy, KSN-District Engineer, this crossing is currently owned by the City of Lathrop. Need to coordinate with the City of Lathrop to submit name change to the CVFPB and for the City to provide future use for this crossing. Recommend internal integrity inspection of section of the pipe through the levee. (DWR UCIP - omagana)5/21/2015 Pipe is still in same condition. Need to contact KSN, LMA engineering firm, to determine update on crossing. (DWR UCIP - omagana)2/04/2010 Pipe wall has corroded through--wall missing from pipe section located on waterward side. Recommend investigating the pipe integrity through levee section. Damage to pipe has eroded the levee slope on waterward side. Recommend LMA superintendent contact owner to stop using crossing and coordinate with CVFPB to address pipe leak. Owner will need to coordinate with DWR inspector and CVFPB. (DWR UCIP - omagana)

View of WS.

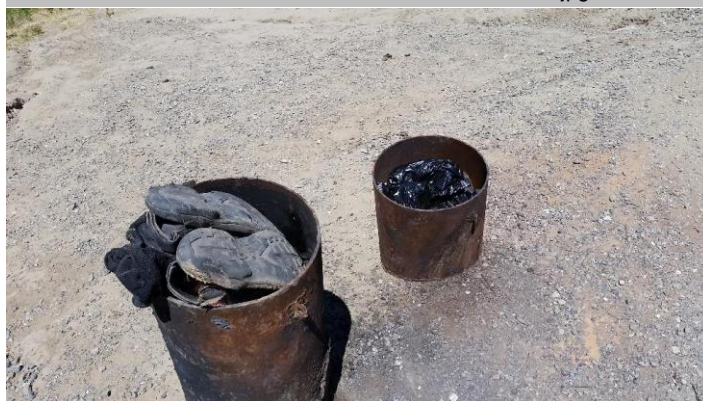
Photo 3 of 3 : UCIP\_SP\_2020\_53331\_75738.jpg

LM Start	<b>8.99</b>	Rating **	U	Issue No.	<b>136 (cont)</b>
LM End	<b>8.99</b>	Issue Type +	En	Location *

WS shoulder--protective housing units for siphon breakers.

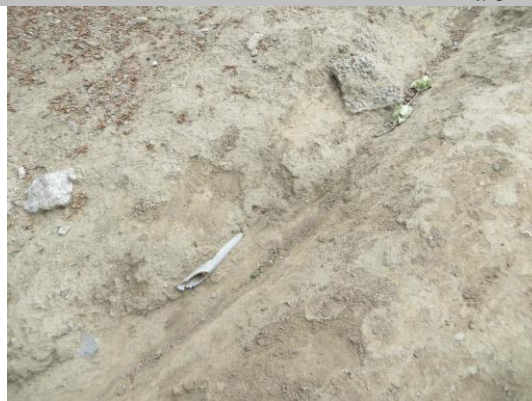
Photo 1 of 2 : UCIP\_SP\_2020\_45453\_74112.jpg

DS\_ID:48  
FS\_ID:45453  
EP\_NO: 15084  
Repair Type: Non-Urgent  
Crossing Status: Indicator Found  
UCIP Comments: Need to contact owner to determine disposition of pipe. No record of removal has been found and status of crossing needs to be determined.  
FIELD\_STRUCT\_DESC: 8-inch steel irrigation pipe through levee, 2.80 feet below levee crown. (Siphon breaker on landside (LS) shoulder. Slant pump on waterside (WS) slope, concrete stairway from pump to WS shoulder, standpipe located 20 feet from the LS toe): Not found. Only indicator is a 1.5-inch PVC electrical conduit visible on WS slope 6-feet below the crown. (8-inch pipe authorized under Permit No. 15084, 1989 - F. G. and B. J. Terry, existing 8-inch pipe removed) [Additional Reference(s): DWR Levee Logs, 1981 and 2003]  
FS Date: 5/21/2015

LM Start	<b>9.09</b>	Rating **	M	Issue No.	<b>137 (cont)</b>
LM End	<b>9.09</b>	Issue Type +	En	Location *

Electrical conduit only appurtanance found on WS slope.

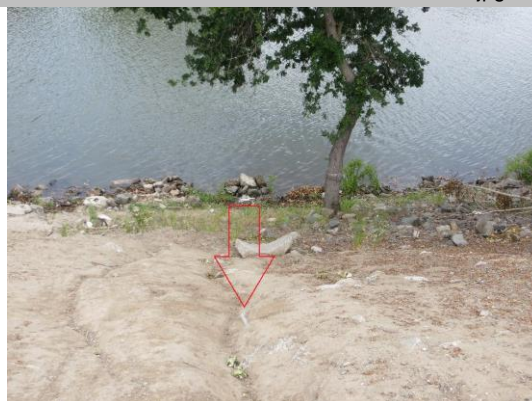
Photo 2 of 2 : UCIP\_SP\_2020\_45453\_74113.jpg

1.5-inch electrical conduit only appurtanance still visible on WS slope.

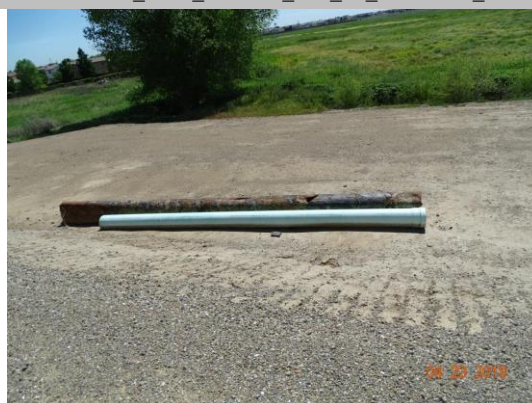
Photo 1 of 1 : SP\_2020\_RD0017\_304\_96\_20200228\_00005.jpg

LM Start	9.67	Rating **	M	Issue No.	96
LM End	9.67	Issue Type +	En	Location *	LS
Category	Earthen Levee			GPS Latitude/Longitude	
				Start	End
Item	Encroachments			37.812380 °	37.812380 °
				-121.316942 °	-121.316942 °
DWR ID	DWR_RD0017_02_s_2019_96				
Comment Code					
DE : Debris					
Inspector Comment					
Farmer is storing drain pipes on landside toe and easement.

View of pipes on landside toe. (Spring 2019)

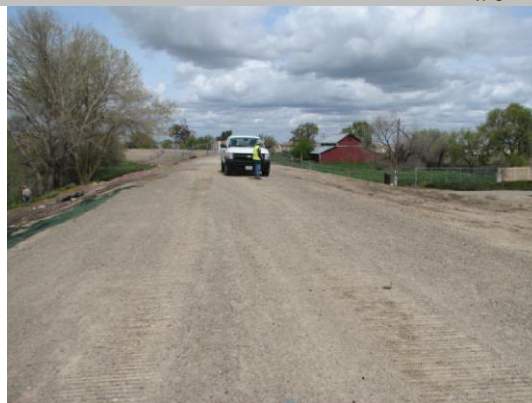
Photo 1 of 3 : UCIP\_SP\_2020\_40695\_72420.jpg

Comment Code					
Inspector Comment					
DS_ID:51 FS_ID:40695 EP_NO: 15055 Repair Type: Non-Urgent Crossing Status: Found UCIP Comments: Pipe is not connected on waterward side. Crossing is non-functional recommend contacting owner to determine status of crossing. If crossing is no longer used need to coordinate with CVFPB for proper abandonment. FIELD_STRUCT_DESC: 16-inch steel irrigation pipe through levee, 2.77 feet below levee crown. Siphon breaker on landside (LS) shoulder. Slant pump on waterside (WS) slope, standpipe located 11 feet from the LS toe. (16-inch pipe authorized under Permit No. 15055, 1989 - F. G. and B. J. Terry, existing 14-inch pipe removed) [Additional Reference(s): DWR Levee Logs, 1981 and 2003] FS Date: 2/4/2010

Overview of levee crown at crossing.

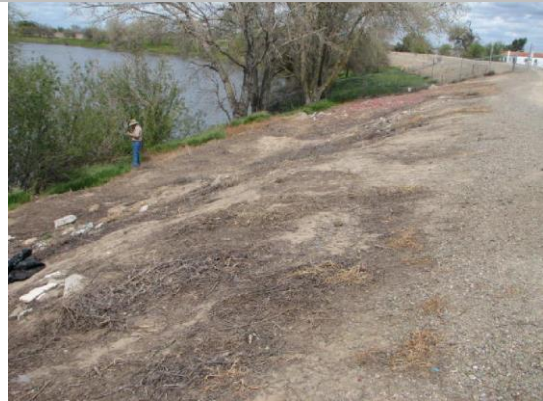
Photo 2 of 3 : UCIP\_SP\_2020\_40695\_72418.jpg

LM Start	11.31	Rating **	M	Issue No.	138 (cont)
LM End	11.31	Issue Type +	En	Location *	
Category	Supplemental			GPS Latitude/Longitude	
				Start	End
Item	DWR UCIP Field Study			37.803410 °	37.803410 °
				-121.312031 °	-121.312031 °
DWR ID	51

View of waterward side.

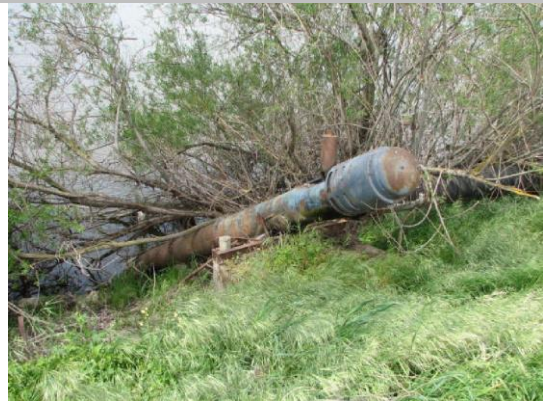
Photo 3 of 3 : UCIP\_SP\_2020\_40695\_72421.jpg

LM Start	<b>11.31</b>	Rating **	M	Issue No.	<b>138 (cont)</b>
LM End	<b>11.31</b>	Issue Type +	En	Location *

Slant pump located on waterward side.

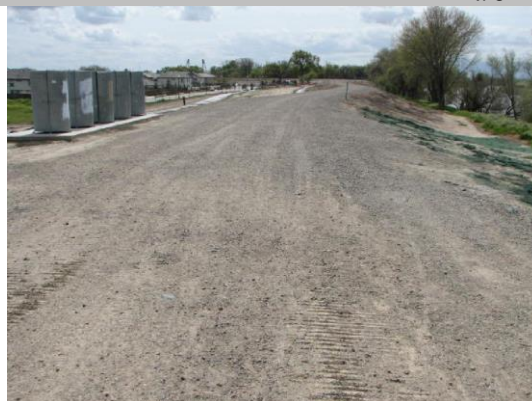
Photo 1 of 3 : UCIP\_SP\_2020\_40696\_72440.jpg

Comment Code						
Inspector Comment						
DS_ID:103 FS_ID:40696 EP_NO: 17792 Repair Type: Non-Urgent Crossing Status: Found UCIP Comments: Surface erosion on waterward slope--Need to contact owner. FIELD_STRUCT_DESC: [Mossdale Outfall] 1 of 6. 30-inch steel drainage pipe through levee at unknown depth. Structure is part of Lathrop City Stormwater Pump Station 112. Station consists 6 drainage pipes, pump station, air release valves, and concrete headwall. Air release valves located inside risers are located on landside (LS) shoulder on top of concrete pad. Concrete headwall and gates located on waterside (WS). (six 30-inch pipes authorized under Permit No. 17792, 2005 - City of Lathrop) FS Date: 2/4/2010

LM Start	<b>11.35</b>	Rating **	M	Issue No.	<b>139 (cont)</b>
LM End	<b>11.35</b>	Issue Type +	En	Location *

Overview of levee crown at crossing.

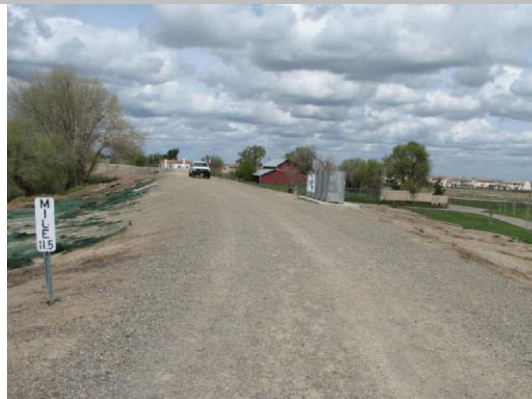
Photo 1 of 3 : UCIP\_SP\_2020\_40698\_72475.jpg

Comment Code						
Inspector Comment						
DS_ID:474 FS_ID:40698 EP_NO: 17792 Repair Type: Non-Urgent Crossing Status: Found UCIP Comments: Surface erosion on waterward slope--need to contact owner. FIELD_STRUCT_DESC: [Mossdale Outfall] 3 of 6. 30-inch steel drainage pipe through levee at unknown depth. Structure is part of Lathrop City Stormwater Pump Station 112. Station consists 6 drainage pipes, pump station, air release valves, and concrete headwall. Air release valves located inside risers are located on landside (LS) shoulder on top of concrete pad. Concrete headwall and gates located on waterside (WS). (six 30-inch pipes authorized under Permit No. 17792, 2005 - City of Lathrop) FS Date: 2/4/2010

LM Start	<b>11.35</b>	Rating **	M	Issue No.	<b>141 (cont)</b>
LM End	<b>11.35</b>	Issue Type +	En	Location *

Overview of levee crown at crossings.

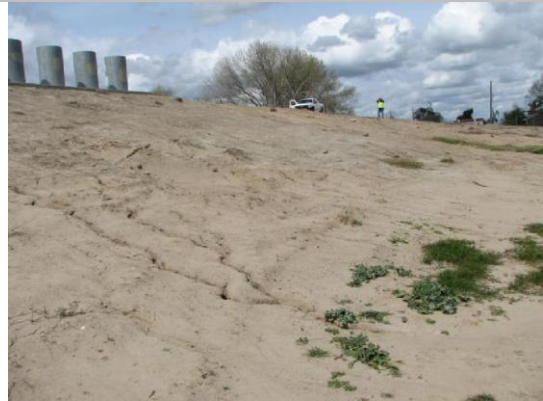
Photo 2 of 3 : UCIP\_SP\_2020\_40699\_72457.jpg

LM Start	11.35	Rating **	M	Issue No.	142 (cont)
LM End	11.35	Issue Type +	En	Location *	
Category	Supplemental		GPS Latitude/Longitude		
			Start	End	
Item	DWR UCIP Field Study		37.802869 °	37.802869 °	
			-121.311948 °	-121.311948 °	
DWR ID	475

View of landward side.

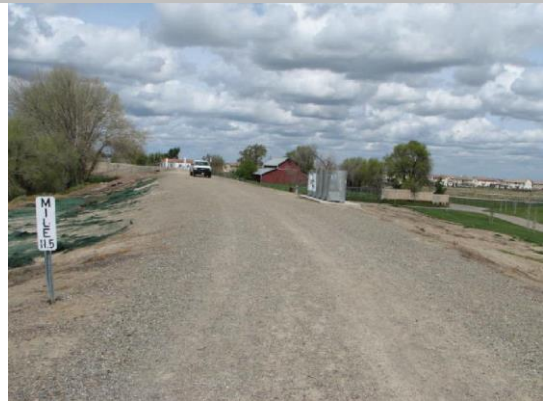
Photo 3 of 3 : UCIP\_SP\_2020\_40699\_72456.jpg

LM Start	11.35	Rating **	M	Issue No.	142 (cont)
LM End	11.35	Issue Type +	En	Location *

Overview of levee crown at crossings.

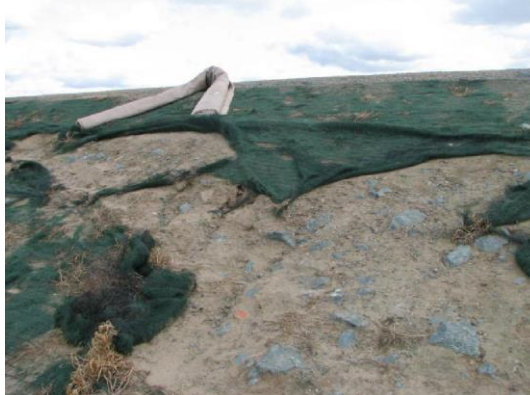
Photo 3 of 3 : UCIP\_SP\_2020\_40700\_72465.jpg

LM Start	<b>11.35</b>	Rating **	M	Issue No.	<b>143 (cont)</b>
LM End	<b>11.35</b>	Issue Type +	En	Location *	
Category	Supplemental		GPS Latitude/Longitude		
			Start	End	
Item	DWR UCIP Field Study		37.802854 °	37.802854 °	
			-121.311948 °	-121.311948 °	
DWR ID	476

Surface erosion on waterward side.

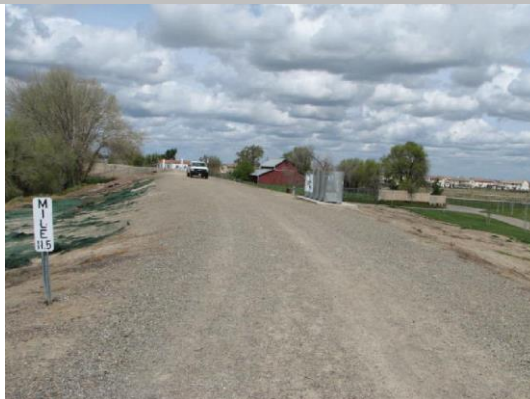
Photo 1 of 3 : UCIP\_SP\_2020\_40701\_72470.jpg

LM Start	<b>11.35</b>	Rating **	M	Issue No.	<b>144</b>
LM End	<b>11.35</b>	Issue Type +	En	Location *	
Category	Supplemental		GPS Latitude/Longitude		
			Start	End	
Item	DWR UCIP Field Study		37.802837 °	37.802837 °	
			-121.311949 °	-121.311949 °	
DWR ID	477

DS\_ID:477  
 FS\_ID:40701  
 EP\_NO: 17792  
 Repair Type: Non-Urgent  
 Crossing Status: Found  
 UCIP Comments: Surface erosion on waterward slope--need to contact owner.  
 FIELD\_STRUCT\_DESC: [Mossdale Outfall] 6 of 6. 30-inch steel drainage pipe through levee at unknown depth. Structure is part of Lathrop City Stormwater Pump Station 112. Station consists 6 drainage pipes, pump station, air release valves, and concrete headwall. Air release valves located inside risers are located on landside (LS) shoulder on top of concrete pad. Concrete headwall and gates located on waterside (WS). (six 30-inch pipes authorized under Permit No. 17792, 2005 - City of Lathrop)  
 FS Date: 2/4/2010

Overview of levee crown at crossings.

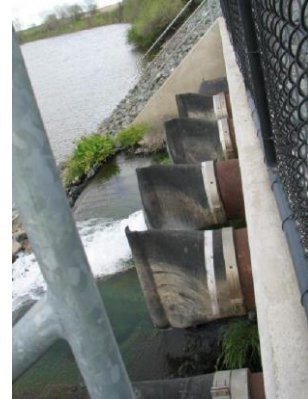
Photo 2 of 3 : UCIP\_SP\_2020\_40701\_72469.jpg

LM Start	11.35	Rating **	M	Issue No.	144 (cont)
LM End	11.35	Issue Type +	En	Location *	
Category	Supplemental		GPS Latitude/Longitude		
			Start	End	
Item	DWR UCIP Field Study		37.802837 °	37.802837 °	
			-121.311949 °	-121.311949 °	
DWR ID	477

Outlet concrete headwall and gates on waterward toe.

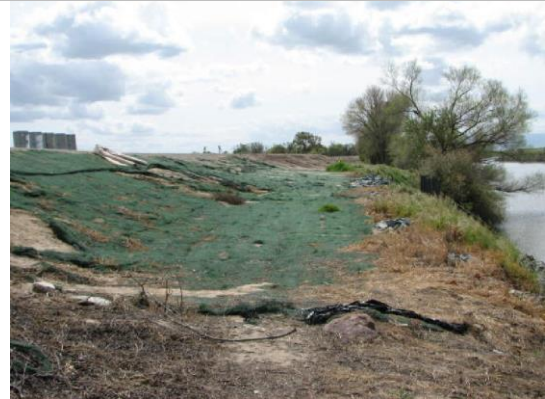
Photo 3 of 3 : UCIP\_SP\_2020\_40701\_72468.jpg

LM Start	11.35	Rating **	M	Issue No.	144 (cont)
LM End	11.35	Issue Type +	En	Location *

View of waterward side.

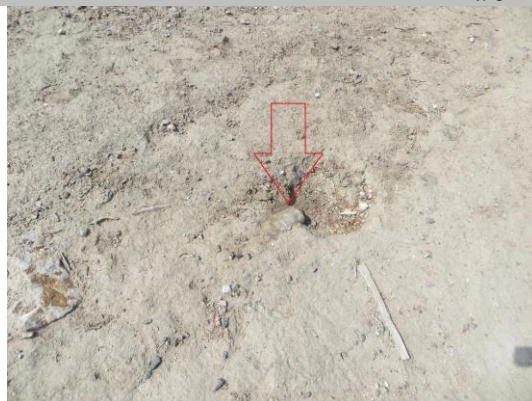
Photo 1 of 3 : UCIP\_SP\_2020\_45463\_74122.jpg

LM Start	11.43	Rating **	M	Issue No.	145 (cont)
LM End	11.43	Issue Type +	En	Location *

Vent visible on WS slope. Found partially burried.

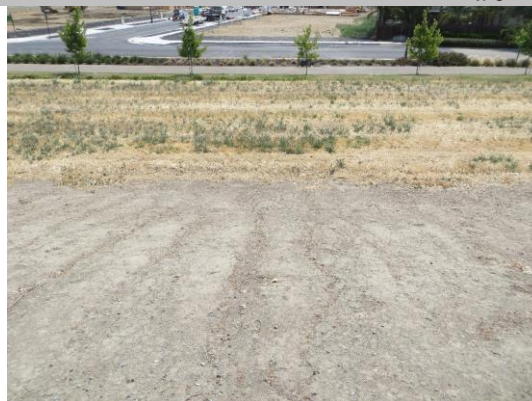
Photo 3 of 3 : UCIP\_SP\_2020\_45463\_74120.jpg

LM Start	<b>11.43</b>	Rating **	M	Issue No.	<b>145 (cont)</b>
LM End	<b>11.43</b>	Issue Type +	En	Location *	
Category	Supplemental		GPS Latitude/Longitude		
			Start	End	
Item	DWR UCIP Field Study		37.801683 °	37.801683 °	
			-121.312001 °	-121.312001 °	
DWR ID	53

LS slope. No indication of pipe.

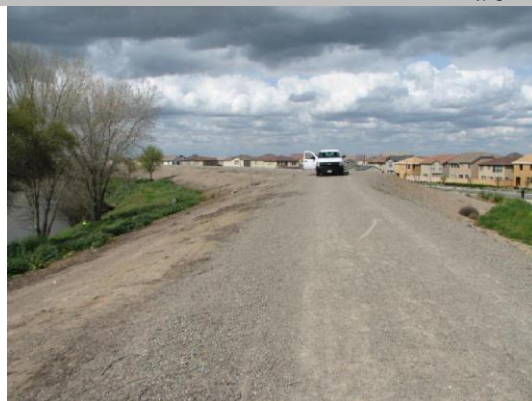
Photo 1 of 3 : UCIP\_SP\_2020\_40702\_72481.jpg

Comment Code						
Inspector Comment						
DS_ID:806 FS_ID:40702 EP_NO: N/A Repair Type: Non-Urgent Crossing Status: Found UCIP Comments: No pipe found during site visit only air valve and power meter. Dense vegetation along waterward slope recommend clearing vegetation from slope to conduct proper pipe inspection. If crossing is no longer in use owner will need to coordinate with DWR inspector and CVFPB to remove according to Title 23 requirements. FIELD_STRUCT_DESC: *REMOVED* 20-inch steel drainage pipe through the levee 5-feet below the crown. Siphon breaker in steel riser on waterside (WS) shoulder and a flap gate on the WS toe. (20-inch pipe authorized under Permit No. 3799, 1961 - Libbey-Owens-Ford Glass Company; 24-inch pipe removed under Permit No. 15318, 1989 - Libby-Owens-Ford Glass Co. & Reclamation District 17 [RD0017], 20-inch pipe installed) [Additional Reference(s): DWR Levee Logs, 1981, 2003, 20-inch. USACE San Joaquin O&M Manual Unit No. 2, May 1963, (HLM 12.16), 20-inch pipe] FS Date: 2/4/2010

LM Start	12.14	Rating **	M	Issue No.	147 (cont)
LM End	12.14	Issue Type +	En	Location *

Overview of levee crown at crossing.

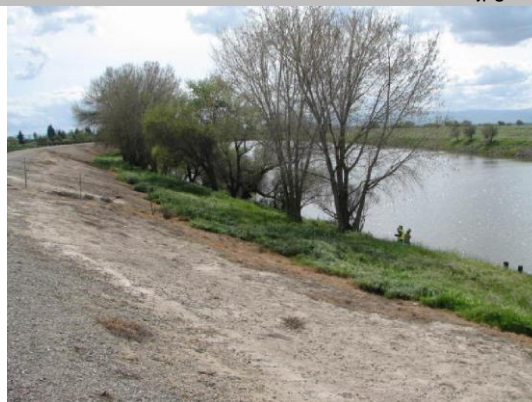
Photo 2 of 3 : UCIP\_SP\_2020\_40702\_72480.jpg

View of waterward side.

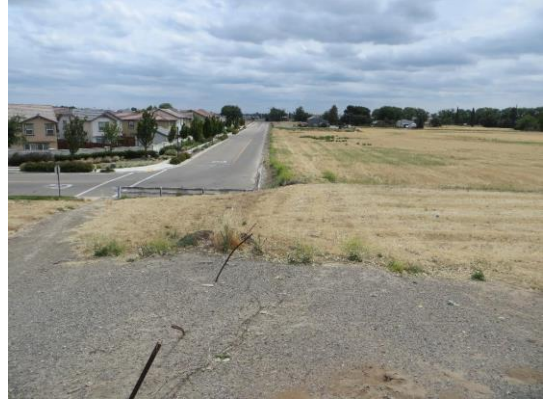
Photo 2 of 3 : UCIP\_SP\_2020\_45464\_74124.jpg

LM Start	12.14	Rating **	M	Issue No.	148 (cont)
LM End	12.14	Issue Type +	En	Location *	
Category	Supplemental			GPS Latitude/Longitude	
				Start	End
Item	DWR UCIP Field Study			37.793831 °	37.793831 °
				-121.305989 °	-121.305989 °
DWR ID	56

View of LS at crossing.

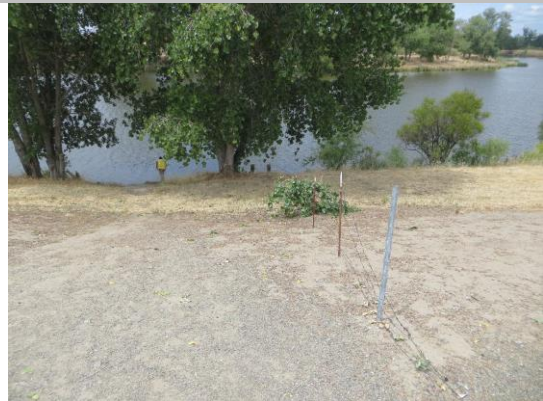
Photo 3 of 3 : UCIP\_SP\_2020\_45464\_74123.jpg

LM Start	12.14	Rating **	M	Issue No.	148 (cont)
LM End	12.14	Issue Type +	En	Location *

View of WS at crossing.

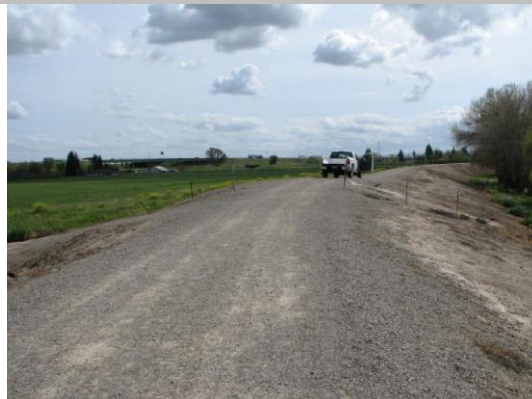
Photo 1 of 3 : UCIP\_SP\_2020\_40703\_72487.jpg

Comment Code						
Inspector Comment						
DS_ID:799 FS_ID:40703 EP_NO: N/A Repair Type: Non-Urgent Crossing Status: Found UCIP Comments: Need to contact owner to determine status of crossing and obtain additional information about crossing (permit and install date). FIELD_STRUCT_DESC: 48-inch steel drainage pipe through the levee, 2.5-feet below the crown. Siphon breaker on landside (LS) shoulder. Concrete "U" shaped headwall on waterside (WS) toe with flap gate. 8-4 inch steel coated scheduled 40 pipes located on WS shoulder about 6 inch cover. (48-inch pipe and 12-inch pipe authorized under Permit No. 15845, 1993 - City of Lathrop and Kearny Ventures) FS Date: 2/4/2010

Overview of levee crown at crossings.

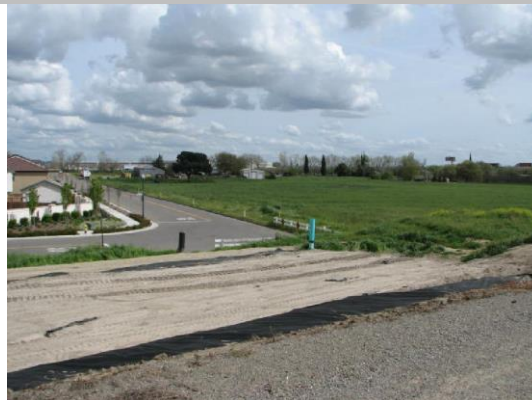
Photo 2 of 3 : UCIP\_SP\_2020\_40703\_72485.jpg

LM Start	<b>12.14</b>	Rating **	M	Issue No.	<b>149 (cont)</b>
LM End	<b>12.14</b>	Issue Type +	En	Location *

View of landward side, photo 1 of 2.

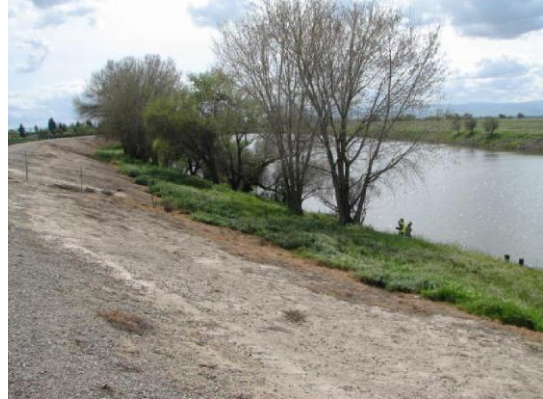
Photo 2 of 3 : UCIP\_SP\_2020\_45993\_72495.jpg

LM Start	<b>12.14</b>	Rating **	M	Issue No.	<b>150 (cont)</b>
LM End	<b>12.14</b>	Issue Type +	En	Location *	
Category	Supplemental		GPS Latitude/Longitude		
			Start	End	
Item	DWR UCIP Field Study		37.793766 °	37.793766 °	
			-121.305986 °	-121.305986 °	
DWR ID	800

View of waterward side.

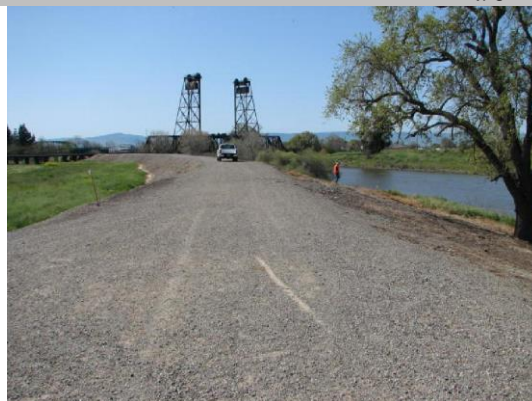
Photo 1 of 3 : UCIP\_SP\_2020\_40706\_72509.jpg

Comment Code						
Inspector Comment						
DS_ID:807 FS_ID:40706 EP_NO: N/A Repair Type: Non-Urgent Crossing Status: Found UCIP Comments: Pipe disconnected on waterward side. Need to contact owner to determine status of crossing. If crossing is no longer in use owner will need to coordinate with DWR inspector and CVFPB to remove according to Title 23 requirements. FIELD_STRUCT_DESC: 8-inch irrigation pipe of unknown material through levee, 3.2-feet below the crown. Pump on waterside (WS) toe and a siphon breaker on the landside (LS) shoulder. (6-inch pipe authorized under Permit No. 15049, 1989 - T. and I. Queirolo, existing 6-inch pipe removed) [Additional Reference(s): DWR Levee Logs, 1981 and 2003] FS Date: 2/4/2010

LM Start	<b>12.41</b>	Rating **	M	Issue No.	<b>151 (cont)</b>
LM End	<b>12.41</b>	Issue Type +	En	Location *

Overview of levee crown at crossing.
